■ Tokyo Station Marunouchi Building-Preservation and Restoration of Exterior Walls

■ Tokyo Station Marunouchi Building – Restoration of the interior of the domes

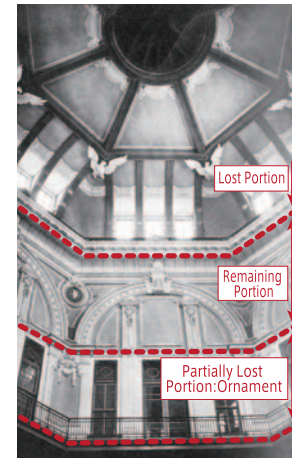
Perspective view of the dome around the time of its opening

The ceiling, which is covered with phoenix reliefs, was burnt down during the war, but the ornamental arches of the third floor miraculously survived intact. As the postwar reconstruction work was done hastily with inadequate preparation, a wooden roof replaced the irreparably damaged dome, and a metallic ceiling in the style of the Pantheon in Rome concealed ornamental arches that were original components of the building. The reinforced concrete columns took the place of ornamental steel columns that had supported a third floor overhang. As a result, the overall effect of the interior was lackluster and rigidly functional without ornamentation. The renovation work in 2012 recreated the original style of the dome and conscientiously restored the ornamental arches above the third floor to the original design.

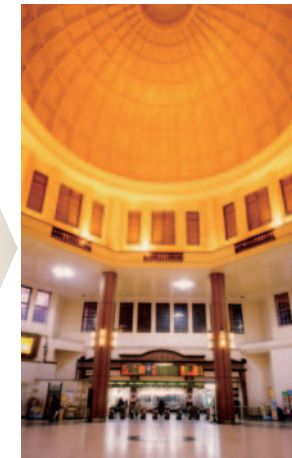
Perspective view of the dome ceiling after post-war restoration

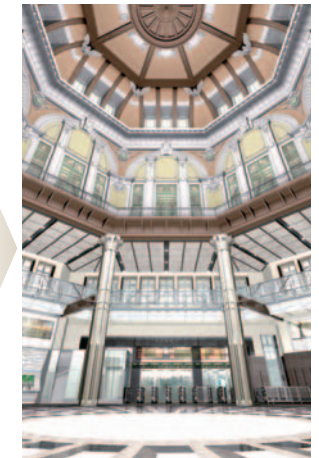
Perspective view of the dome ceiling after restoration

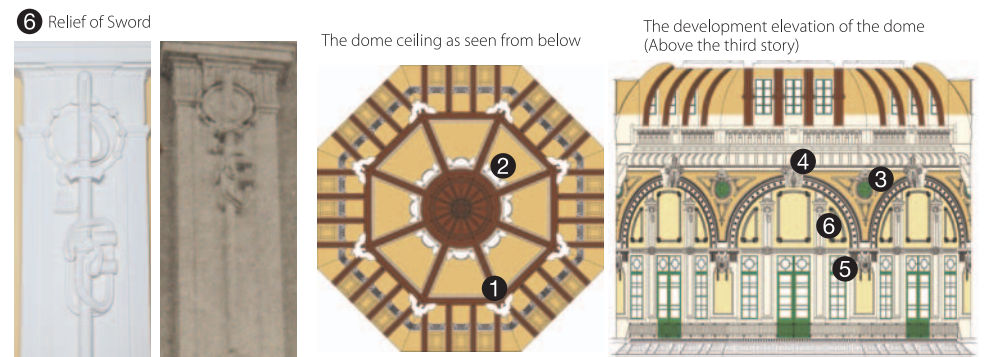
Notable ornaments such as oriental zodiac signs and eagles spanning over 2 m across the dome were white photographs were taken around the time of the foundation of the building.)
